Atypical rupture of a Poly Implant Prothèse implant and fluid shifting: a case report

Jae Chung Min, Eun Key Kim

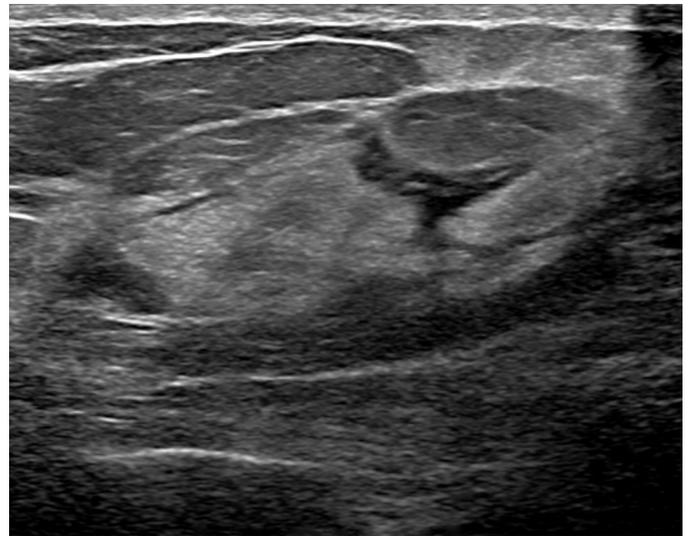
Fig. 2. Ultrasonography of the left lower-outer quadrant. Diffuse heterogeneous parenchymal echotexture was observed.

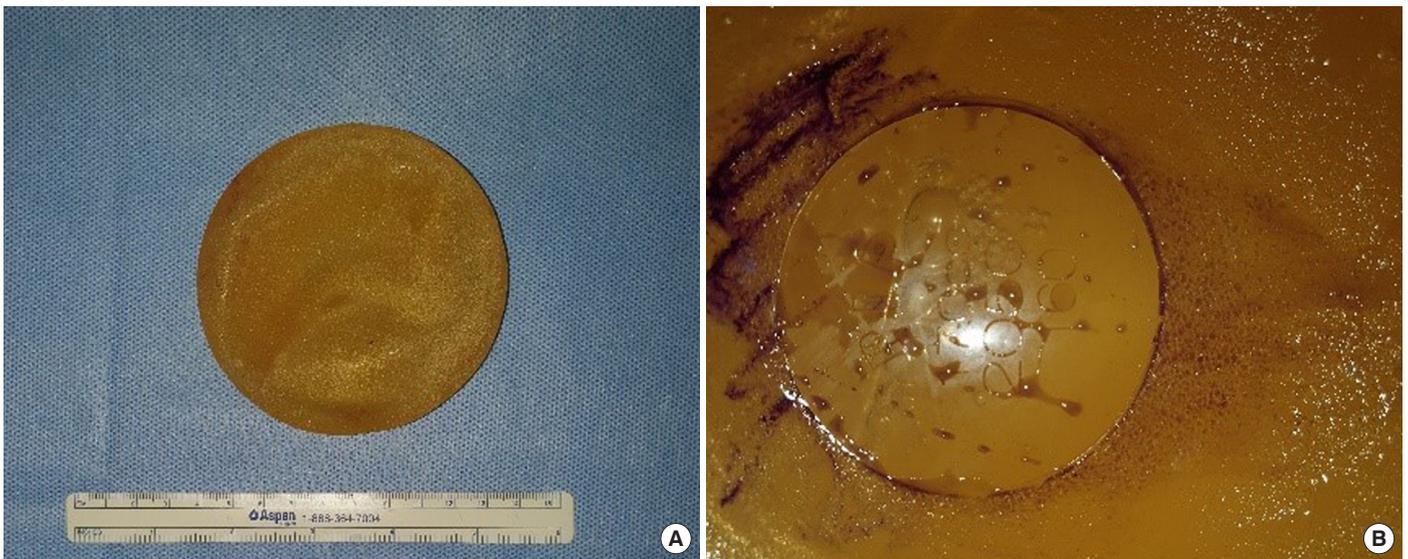
Fig. 3. Explanted left breast implant. (A) There was no remarkable tear in the shell. (B) A yellowish fluctuating sticky fluid was observed within the shell, which was not mixed with the remaining hydrogel.

Both implants were removed through inframammary incisions. It was determined that the implants used for this mammoplasty augmentation were manufactured by PIP. Within the silicone shell, a yellowish fluctuating sticky fluid was observed that had not mixed with the remaining hydrogel, and no remarkable tear was found in the shell (Fig. 3). The right implant had no fluid inside the intact capsule. Following fluid culture, cytology, and biopsy of the left breast tissue, copious irrigation was performed. Mastopexy with an inverted T scar design was performed on both breasts. Cultures of the fluid from both breasts detected no bacteria or fungal growth, and the cytology test came back negative for malignant cells. A biopsy of the left breast tissue revealed foamy histiocytic infiltration and clinical implant rupture. No complications related to the operation have been noted for several months postoperatively.
